The EC 225 LP accident near Turøy in Norway

The Second Loss of a Helicopter Main Rotor - Need for a Change in Certification and Continued Airworthiness of Large Rotorcraft?

By Kåre Halvorsen and Tor Nørstegård (AIBN)

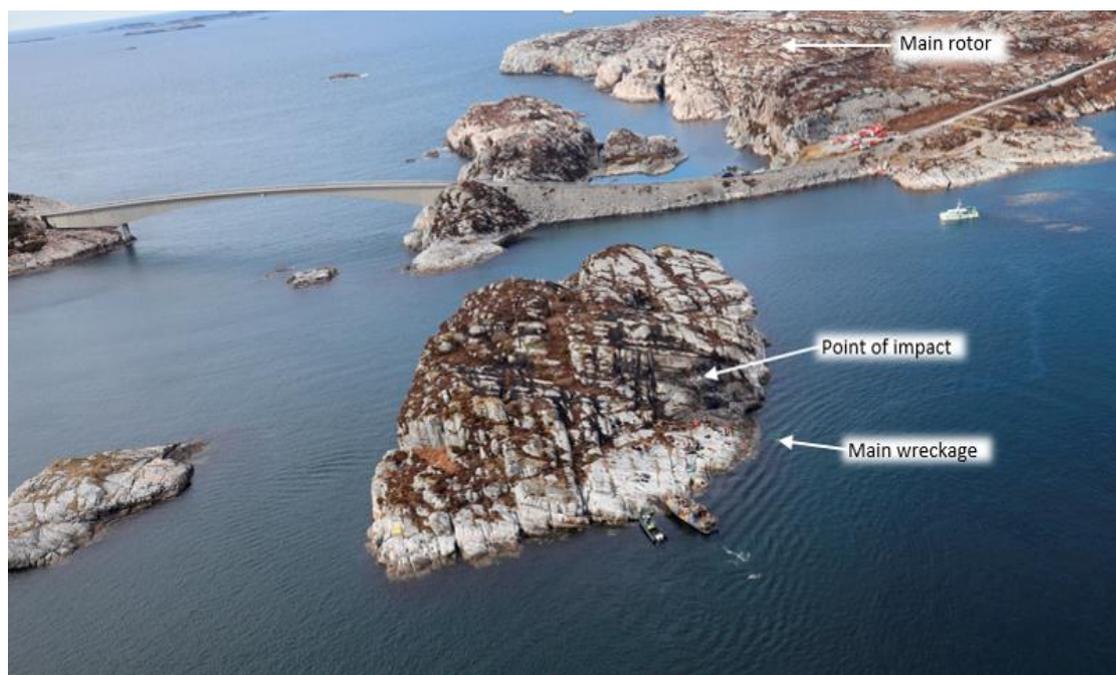
Wreckage parts were spread over a large area both at land and in the sea. The Main Rotor landed on an island about 550 meters north of the crash site (See Figure 1). The impact forces destroyed the helicopter, before most of the wreckage continued into the sea. Fuel from the helicopter ignited and caused a fire onshore.

Figure 1: The accident site.

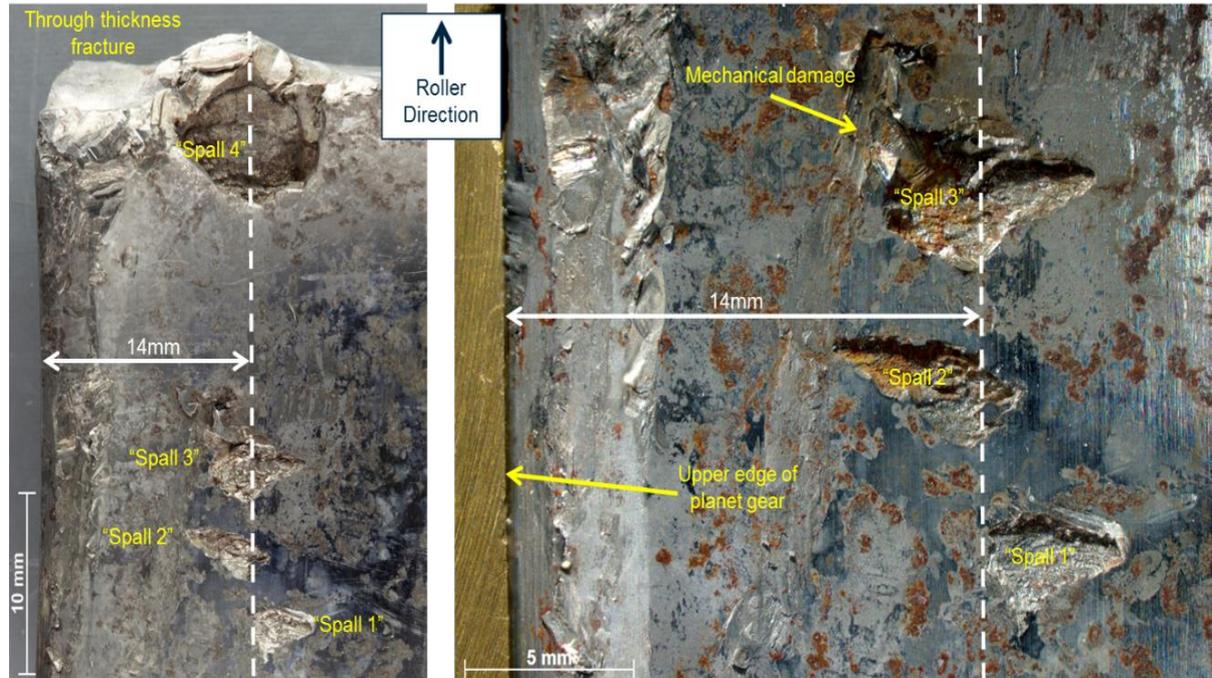
The fatigue fracture initiated from a surface micro-pit in the upper outer race of the bearing (inside the second stage planet gear), propagating subsurface while producing a limited quantity of particles from spalling, before turning towards the gear teeth and fracturing the rim of the gear. Four spalls were observed centred along the line with maximum contact pressure (See Figure 6).

Figure 6: Investigators found spalling inside the second stage planet gear.

It is probable that the failure was initiated by debris caught within the bearing and scratching one or more rollers. This probably caused a band of local work hardening and associated micro-pitting at the outer race. The AIBN concludes that the fatigue fracture were neither a consequence of a mechanical failure or misalignment of another component, nor due to material unconformity. More research is needed in order to understand the fatigue behaviour for the material. It has not been possible to determine a conclusive crack propagation rate, but it must have developed within a maximum of 260 flight hours since the gearbox was inspected and repaired at Airbus Helicopters. The repair was done following a road transport incident.
