UNSTABLE APPROACHES: A Global Problem

David Ross, MO5600
Senior Regional Operations Investigator
Transportation Safety Board of Canada

Mr. Ross worked as the operations team leader, and chair of the flight operations and weather groups, during the TSB investigation of a Boeing 737 controlled flight into terrain accident at Resolute Bay, Nunavut, on 20 August 2011. (1)

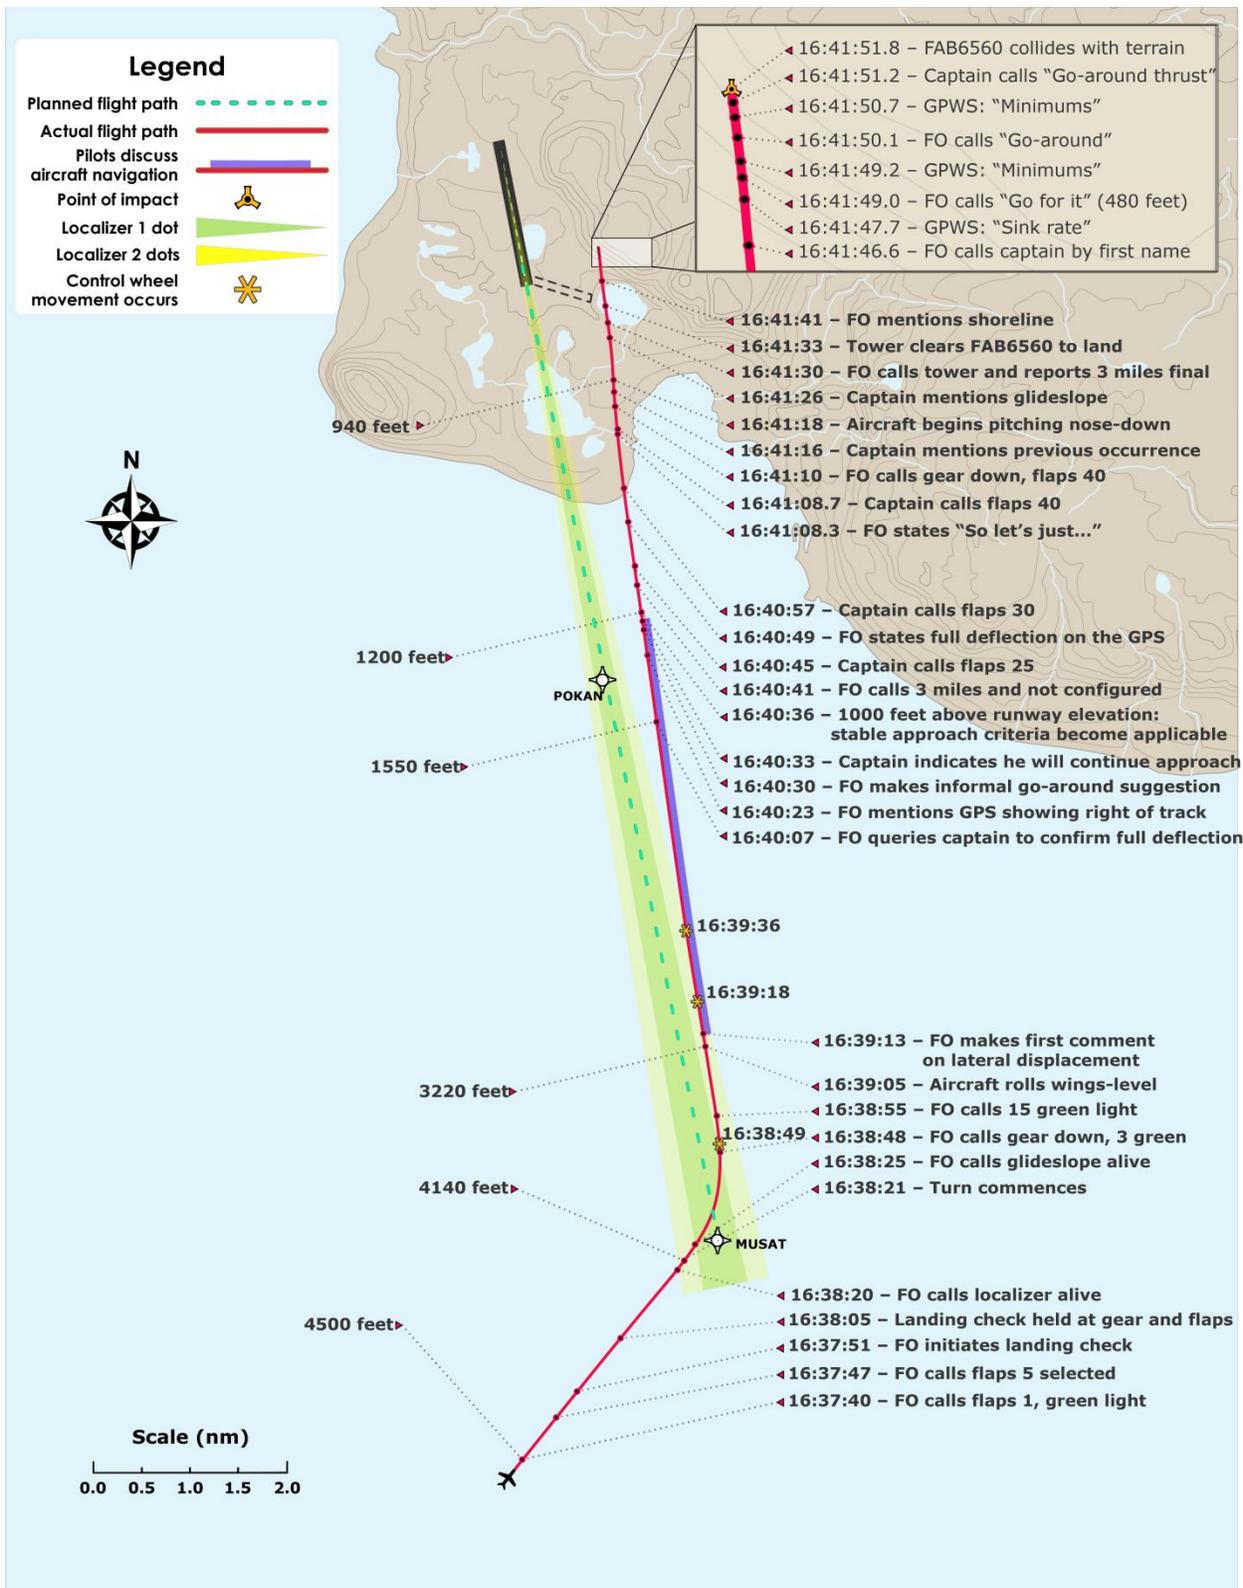
Figure 3: Sequence of Events, Plan View

+	FAB6560 descends through 1220' ASL with 178 KIAS, 1.3 EPR and decreasing, gear down, and flaps 15.	20/08/2011 16:40:36
	First officer points out they're three miles and not configed.	20/08/2011 16:40:41
+	Captain continues approach despite go-around requirement for unstable approach.	20/08/2011 16:40:41
+	Captain calls for flaps twenty-five.	20/08/2011 16:40:45
	First officer reports full deflection on the GPS too.	20/08/2011 16:40:49
+	First officer recommends corrective action - go left.	20/08/2011 16:40:52
+	Captain indicates he can't go left.	20/08/2011 16:40:54
+	Borek909 enters control zone under IFR with no ATC separation plan from FAB6560.	20/08/2011 16:40:55
	First officer cautionary statement (re track) cut off by captain's flaps 30 call.	20/08/2011 16:40:56
+	Captain calls flaps thirty while FO raises concern regarding navigation..	20/08/2011 16:40:57

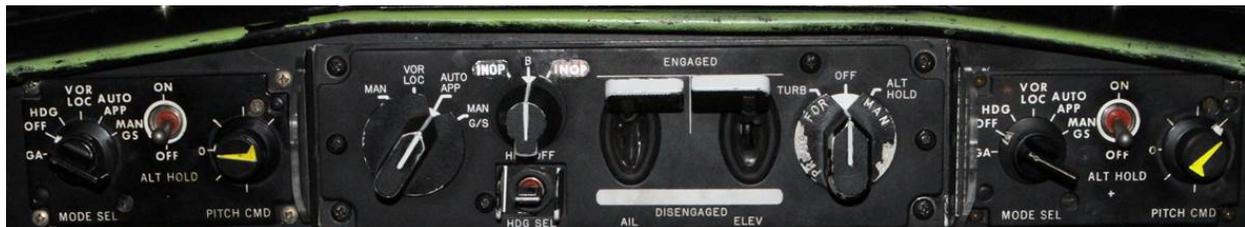
Figure 8: Autopilot/Flight Director Mode Control Panel

The FDR showed that the autopilot was engaged throughout the arrival of flight 6560. The captain would have needed to make both autopilot and flight director mode selections (Figure 8) as the flight approached from the southwest toward the localizer. However, only the autopilot engagement status was included in the limited number of parameters on the FDR. Additionally, the operator's standard operating procedures at the time did not require crew callouts of mode selections or changes, and none were recorded on the CVR. The challenge to the investigation was to understand and explain how the pilots likely operated these systems and what information they had available during the approach.

This portion of the investigation produced two findings as to causes and contributing factors. First, that, as the aircraft rolled out of the turn onto final approach, the captain likely made a control wheel roll input that caused the autopilot to change to a mode wherein the aircraft rolled to and maintained wings level, and that the crew did not detect the mode change. Second, that the flight directors likely subsequently changed modes, resulting in a change of pilot roll guidance.

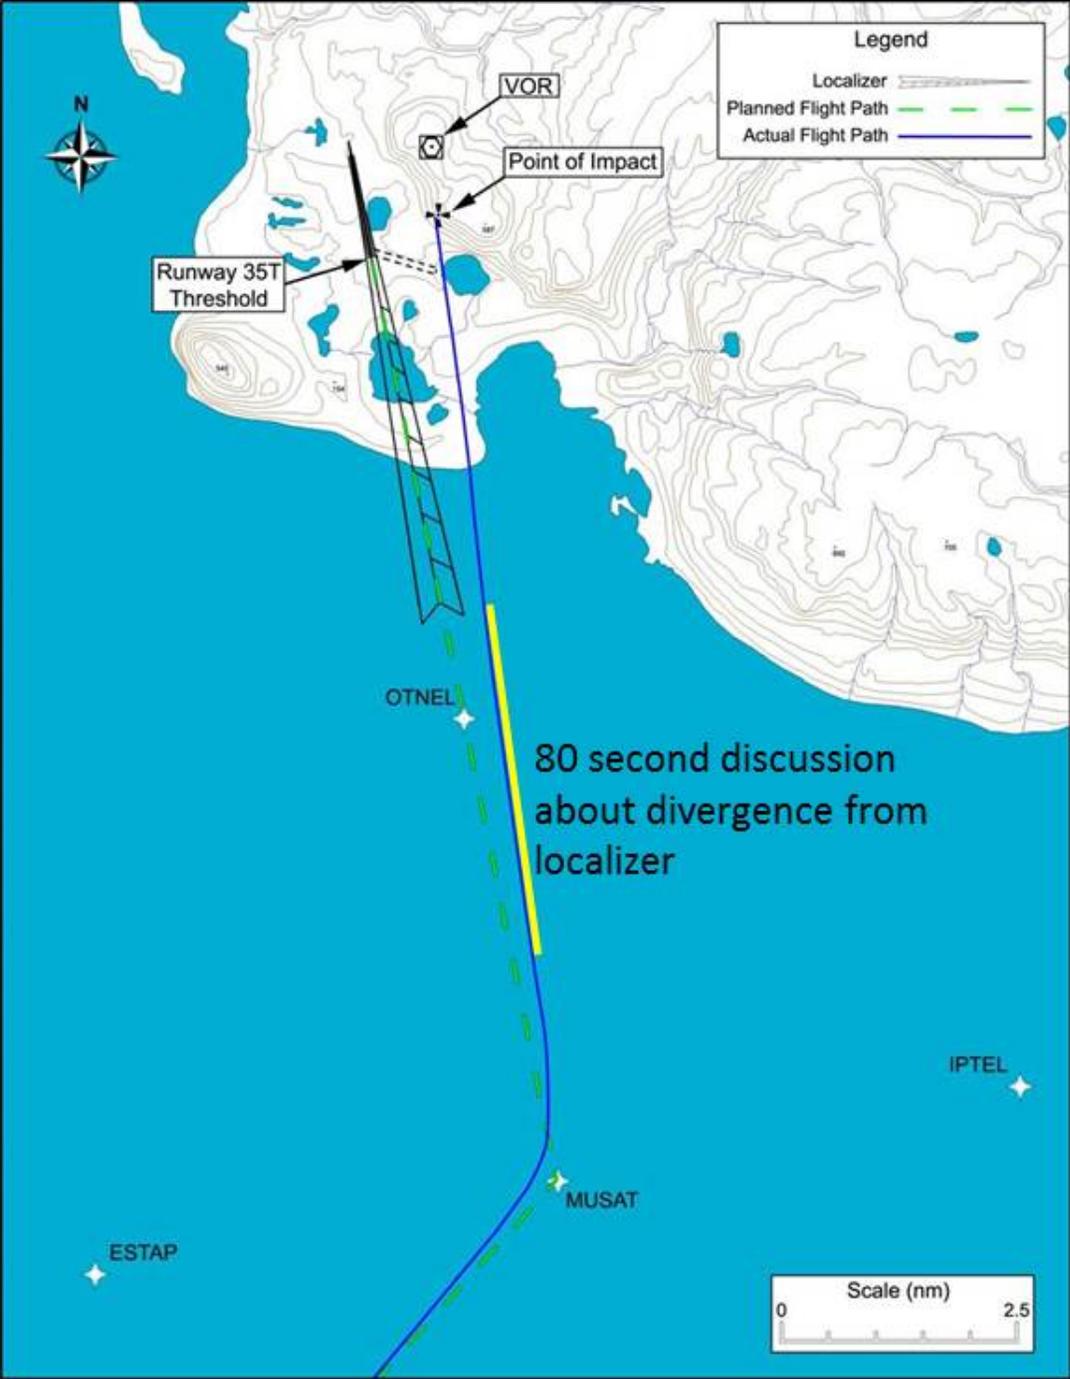
Figure 11: 80-second discussion about divergence from localizer

Ineffective workload management resulted in the flight 6560 pilots becoming task-saturated and shedding tasks during the final two minutes of the flight. A prime example of this was an 80 second discussion on final approach about the flight's divergence from the localizer (Figure 11). During this period the crew became immersed in the navigational issue and did not action the remaining landing checklist items to finish configuring the aircraft for the approach. Once final configuration changes did occur, they were hurried and neither pilot made all of the specified callouts.

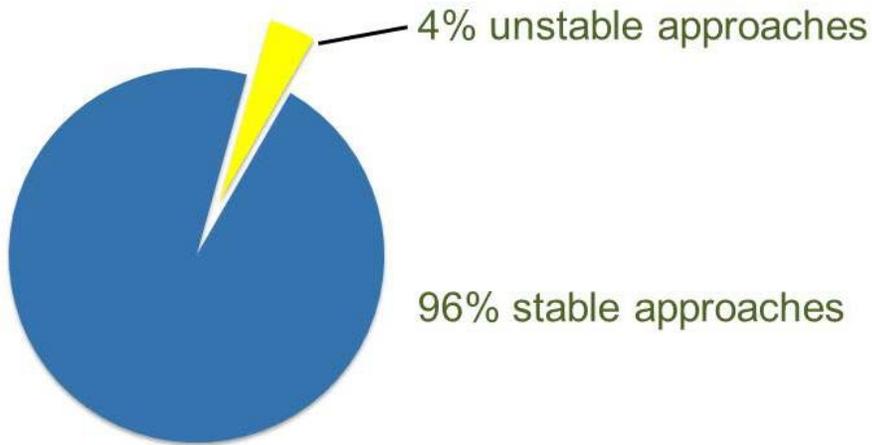
Figure 12: Unstable Approaches

LOSA observations of over 20,000 flights show that 4% of those flights had an unstable approach (Figure 12), and that 97% of the unstable approaches continued to a landing (Figure 13). On only 3% of unstable approaches did the crews execute a go-around. (2)
