Links for a successful investigation C-212 Robison Crusoe Island Accident Case

by Luis Gracia
Airbus Defence & Space – Military Aircraft
Head of Product Safety
ISASI Member: CP0323

The study case presented is linked to the accident happened on September 2nd, 2011, with the C-212 Series 300, Model DF MSN 443, operated by the Chilean Air Force (FACH), where the aircraft was lost into the sea while performing a second approach to the Robison Crusoe Island airport (Juan Fernandez Archipelago - Chile) in high crosswind and bad weather conditions.

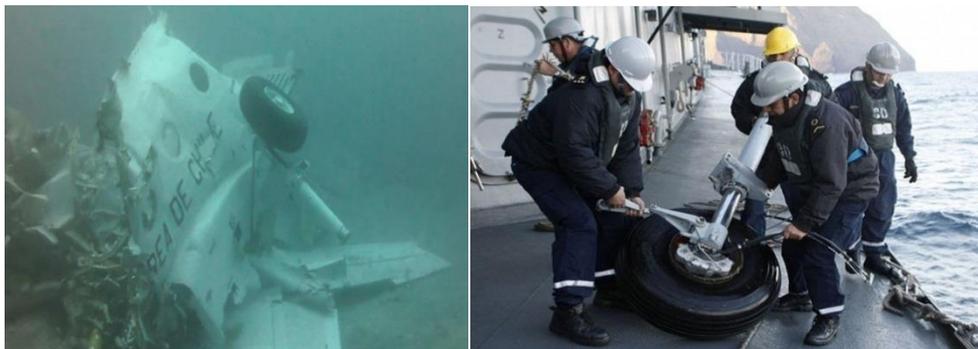
Figure 5

Aircraft wreckage was found on the seabed, at a depth of 50 m., in line with the direction set by the channel between the islands, some days later.

Only few parts like the ramp, a MLG wheel, and other light internal parts (cushions ...) were found floating in the sea. Chilean Authorities used two sea robots for seabed screening and for supporting the work of the divers in the bodies and some aircraft light parts recovery (propellers, instrument cockpit panel ...). Those sea robots took videos and GPS position from the different parts found in the bottom.

Two and a half months after the accident, a major rescue operation was performed to recover the wreckage from the sea floor. That wreckage was moved to a hangar, where it was laid out for airplane reconstruction.

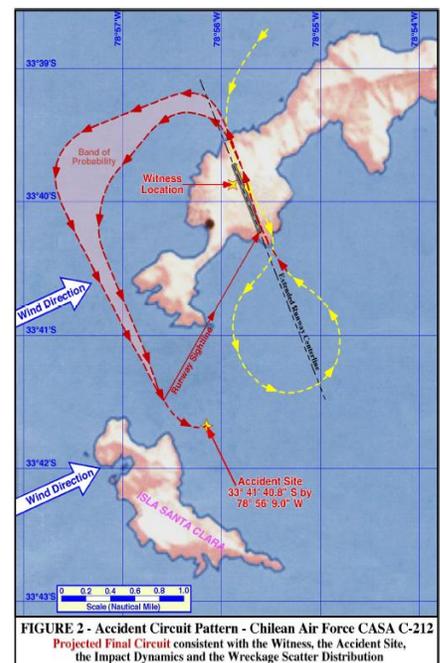
Figure 10

FIGURE 2 - Accident Circuit Pattern - Chilean Air Force CASA C-212
Projected Final Circuit consistent with the Witness, the Accident Site, the Impact Dynamics and the Wreckage Scatter Distribution

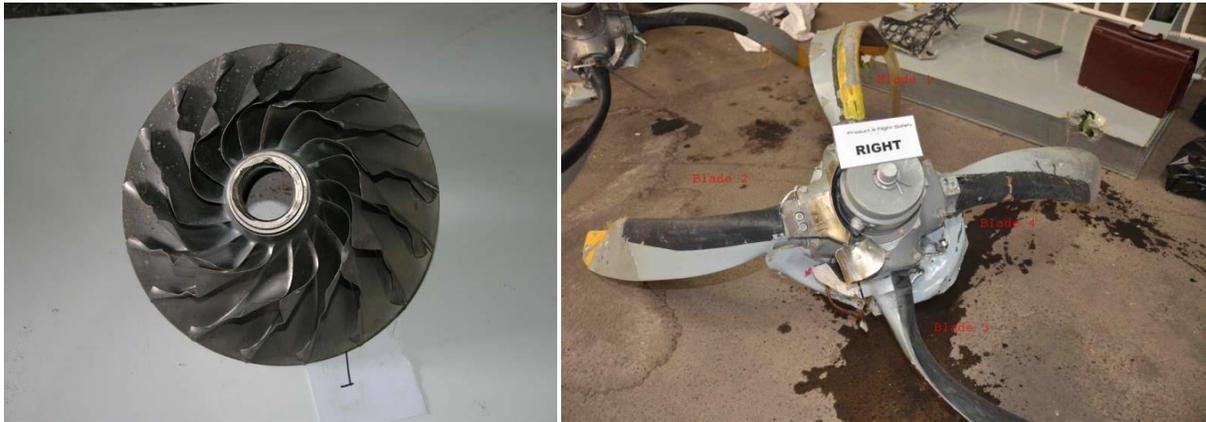
Figure 12

Both engines were partially disassembled for rotating parts examination. The damages exhibited were consistent with both engines operating at the time of impact. The damages observed in the curvics of the turbine impellers suggest medium /high power setting. The damage observed among the rotating parts was consistent with the turbine overdriving the compressor when the rotating propellers were slowed by the action of water.

For the propellers, it was concluded that both propellers were rotating at the time of impact. Based on the bending of the blades, the propellers were with power and were operating within their normal flight range. Initial propeller damage occurred at the time of impact with water and the secondary damage was consistent with a propeller under power entering into the water and being driven aggressively into reverse by the increase on torque caused by the density change from air to water.

So, it was also concluded that both engine were operating in the normal range at the time of the accident.

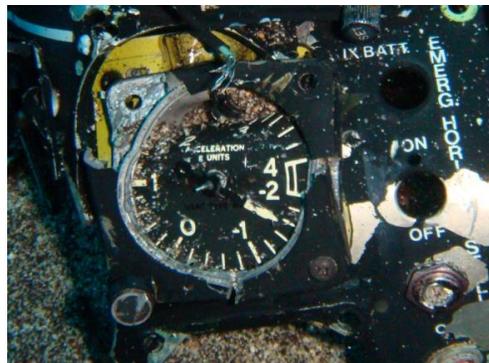
Figure 13

Both propellers RPM indicators showed marks around normal range. Flaps indication was around 14% where APP/TO (25%) was the recommended deflection for landing in high cross-winds condition.

The most relevant information was provided by the g's indicator, where the needle was pointing to a negative vertical acceleration of -1.6 g's. Aircraft flying in inverted position with a significant downwards acceleration.

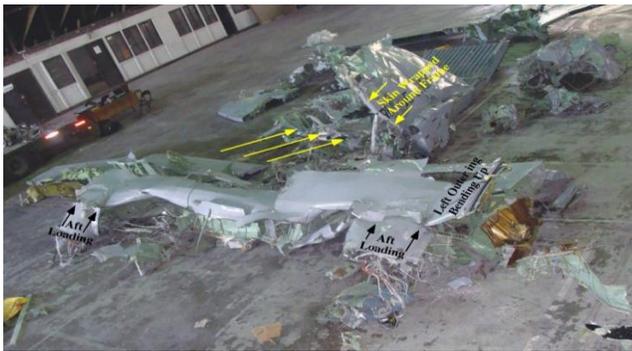
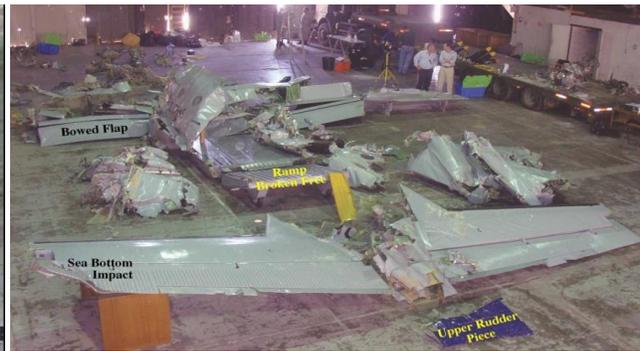
Aircraft structural integrity at the crash time was confirmed based on recovered parts and the examination of underwater videos. All control surfaces were found, as well as some of the wing parts and the stabilizers.

Aircraft recovered parts were laid out on a hangar for aircraft reconstruction. When all recovered parts were displayed in their position into the aircraft, the following findings were observed:

- No large sections of the outer left wing were recovered. Structure was scattered in many small pieces. A small leading edge part recovered was completely flattened. All these factors showed the left wing impacted on the water with high energy. Before that, the wingtip was ripped off when it touched the water.
- The outer right wing slammed into the water symmetrically along the leading edge. It is broken up into much larger sections than the left wing showing that impact occurred at a lower energy.
- Aircraft nose was destroyed but rotated 30° to the right as it could be observed in the lower fuselage beams.
- The ramp travelled forward.
- The upper fuselage skin was ripped off by water surface friction loads.
- The vertical fin had pulled away from the rear fuselage.

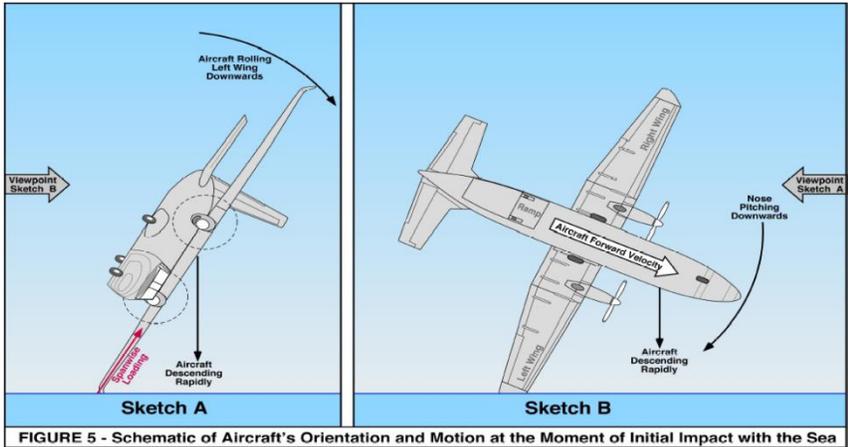
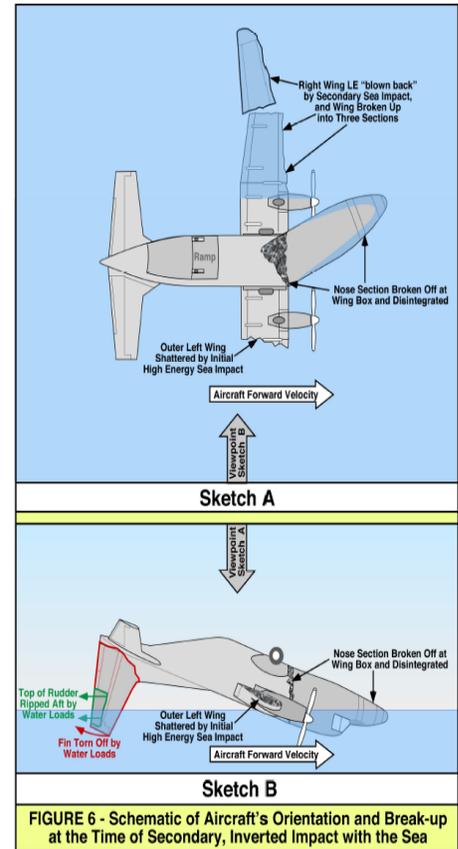
It was concluded that the aircraft struck the ocean in an abnormal attitude with significantly past 90° left bank. Aircraft was inverted and still rolling to the left while side-slipping to the left. The break-up sequence shows the aircraft was flying forward (it had forward momentum), but it was also a quickly dropping (side-slipping) to the left.

The aircraft nose was also dropping, but, however, aircraft did not cartwheel. It rolled inverted while the outer portion of the left wing was slicing into the water and literally shattering from water forces.

At the same time, the aircraft nose and cockpit were destroyed when impacted the water and rotated some 30° to the right, while being crushed rearwards by water forces.

When the aircraft rolled totally inverted, the right wing slammed into the ocean and broke into three large sections. The top of the fuselage was rippled like accordion by water friction forces, and the rear fuselage and dorsal fin displayed hydraulic crushing on the right side.

The vertical fin was ripped away from the rear fuselage attachment, showing the aircraft had forward momentum throughout its destruction.

The horizontal stabilizers were the less damaged parts as most of the impact energy was already dissipated by the crushing of others parts. The right inverted horizontal stabilizer struck the water first (aircraft banked 15° “left”) causing diagonal compression while the left stabilizer only showed inertial effects.

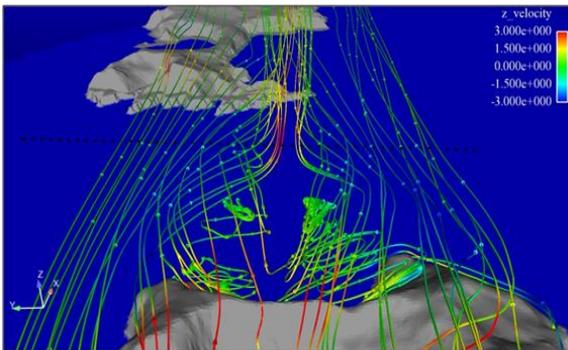
Figure 20

Four wind directions were tested: 210° , 240° , 270° y 300° . The results showed that the rugged terrain and the sharp shape of Santa Clara Island, with dimensions of 3 km x 1,5 km and a maximum height of 1.226 ft., resulted in the appearance of two downwind vortexes, with high instability. These two vortex tubes are dragged along the wind direction towards Robinson Crusoe Island (see Fig. 20), resulted in a really instable wake for any aircraft crossing through.

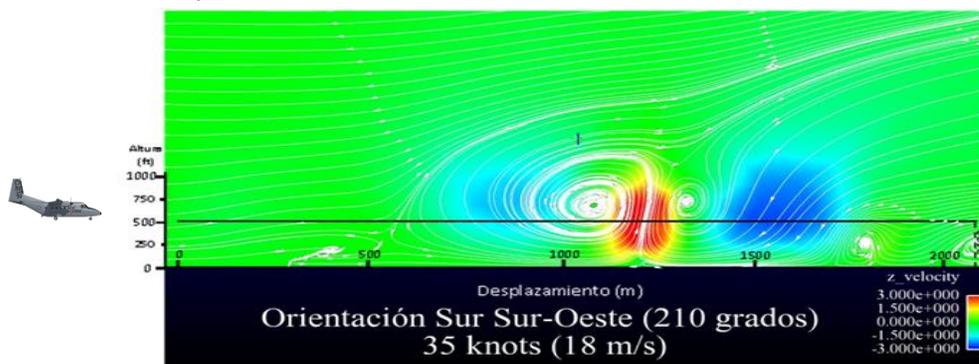
Figure 22

As it can be seen in Fig. 22, one aircraft flying at 500 ft. through the channel between both islands would find significant downwind (blue) followed by upwind flows (red) and finally stronger downwind (blue) when crossing through these counter rotating vortexes. It happens along less than 1.000 meters that means about 15 second for the normal aircraft airspeed.

In such situation, the difficulty to maintain aircraft control become evident, especially when it is combined with the convective flow resulted from the meteorological situation.
