BCA Aviation Safety & Equipment Quality Analysis

Collaborative Component Examinations

Eric East – Air Safety Investigator
Boeing Commercial Airplanes

ISASI 16
17 - 20 October 2016
Reykjavík, Iceland

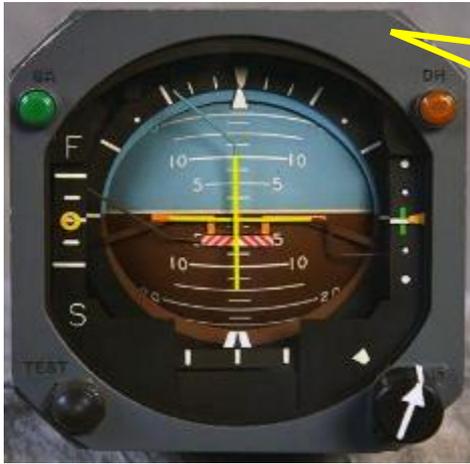
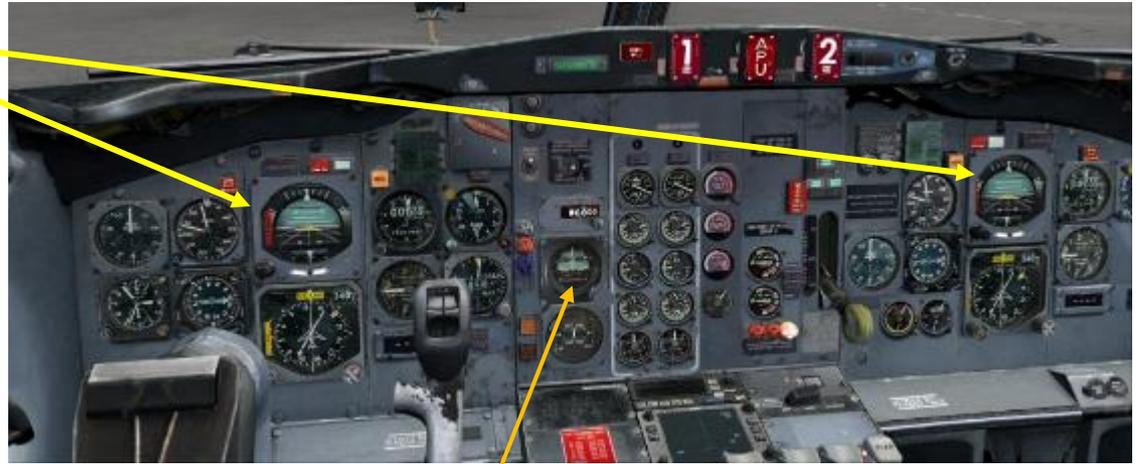
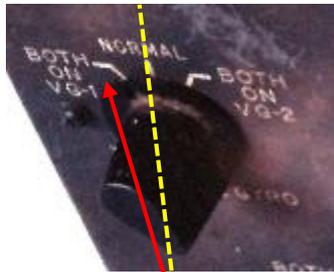
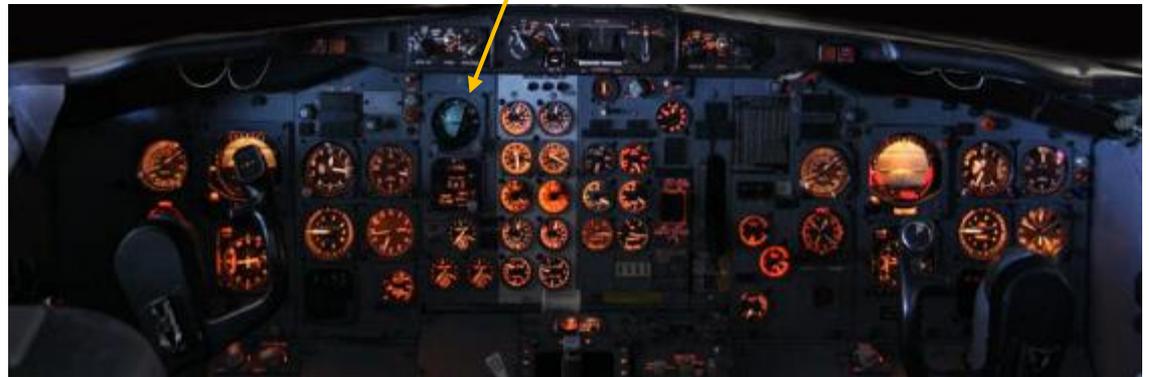
Found in “BOTH ON VG-1”

Selector panel (*both on VG1*)

Vertical gyro – roll synchro remnant

Standby horizon indicator

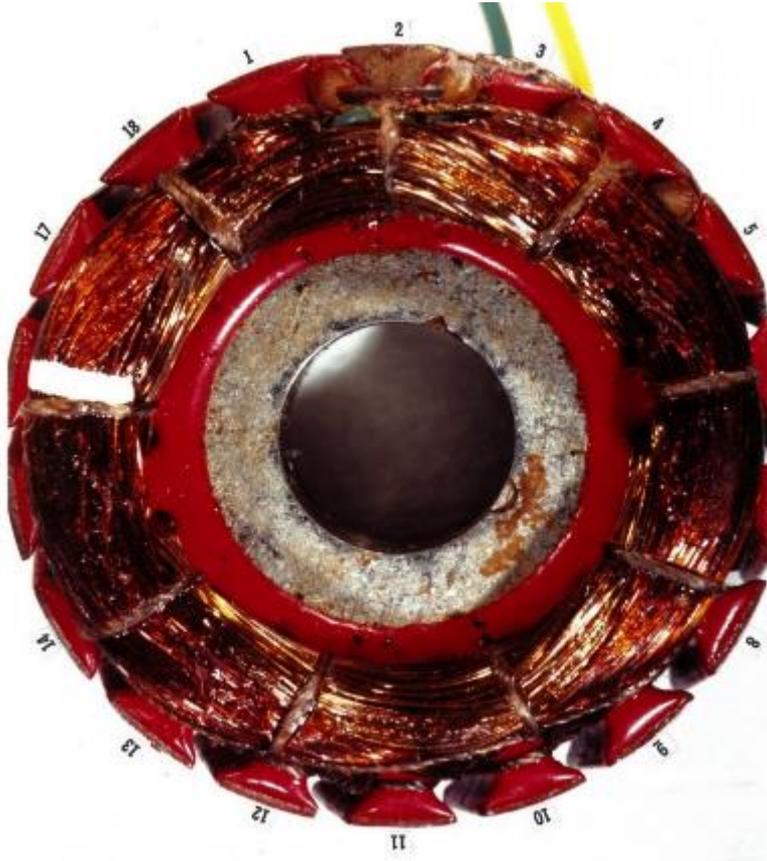
Vertical Gyro #1
Roll Synchro Rotor

EQA found:

- Broken wire in the selector panel (may have been overload from impact)
- Compromised winding in the rotor from VG1- resulting in intermittent short to ground manufacturing flaw

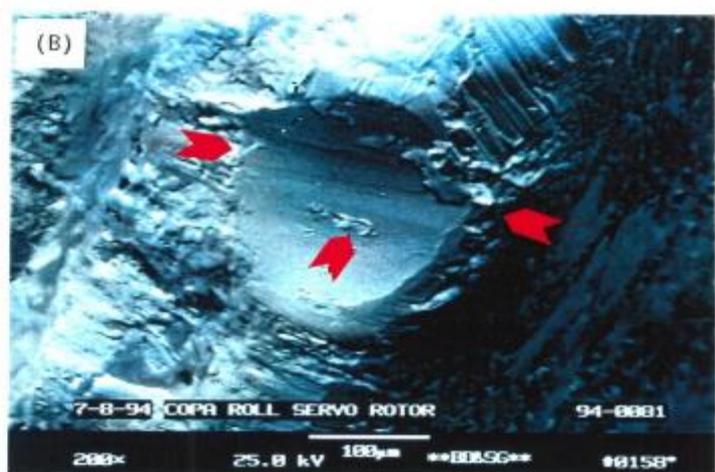
Experience of participants utilized to recognize patterns during physical examination to determine damage caused by manufacturing flaw and not impact.

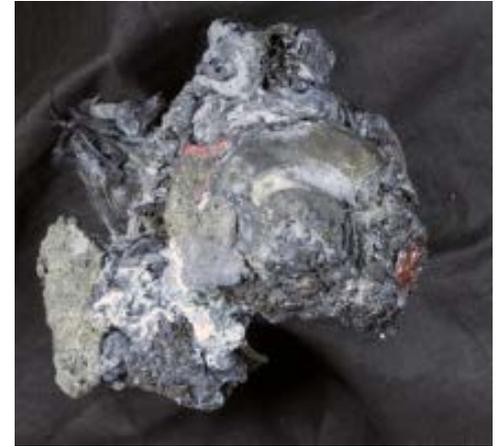
- During pushback an oxygen fire erupted
- All passengers and crew safely evacuated
- Left side cockpit mostly destroyed by fire
- “Flame holder” traced to oxygen mask storage box
- Mask found outside storage box

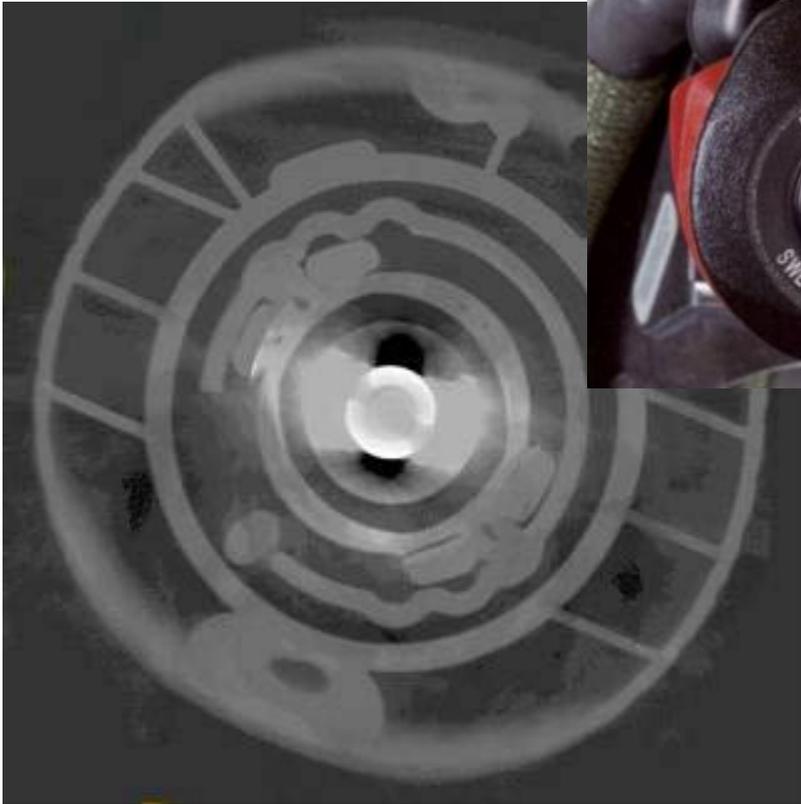
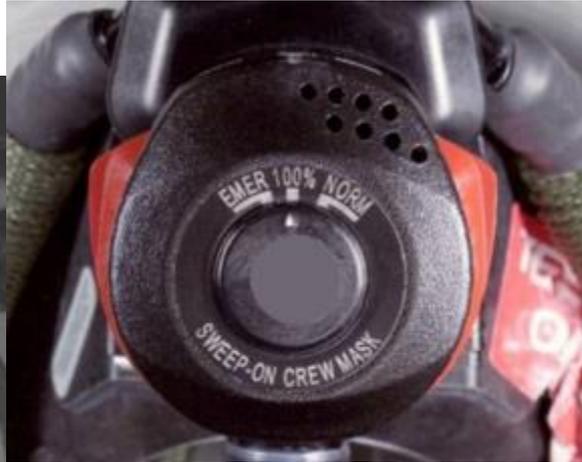
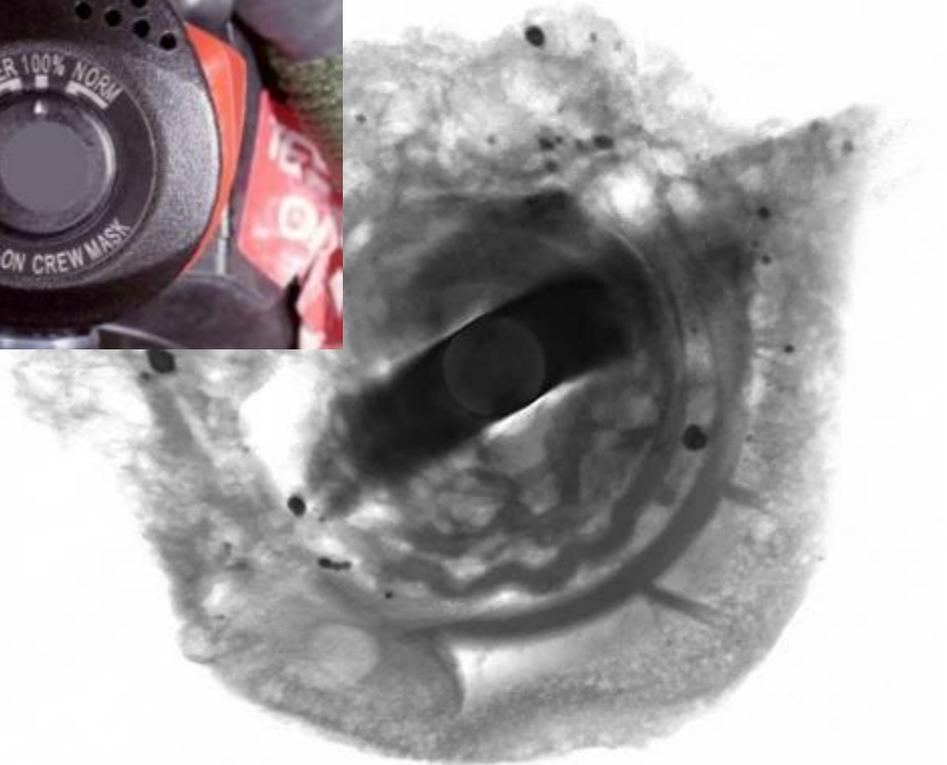
Comparative Analysis

Exemplar

Event Mask

Ability to evaluate and perform iterative comparative analysis of internal component position using on site digital radiography (DR) and computed tomography (CT) technology and expertise.

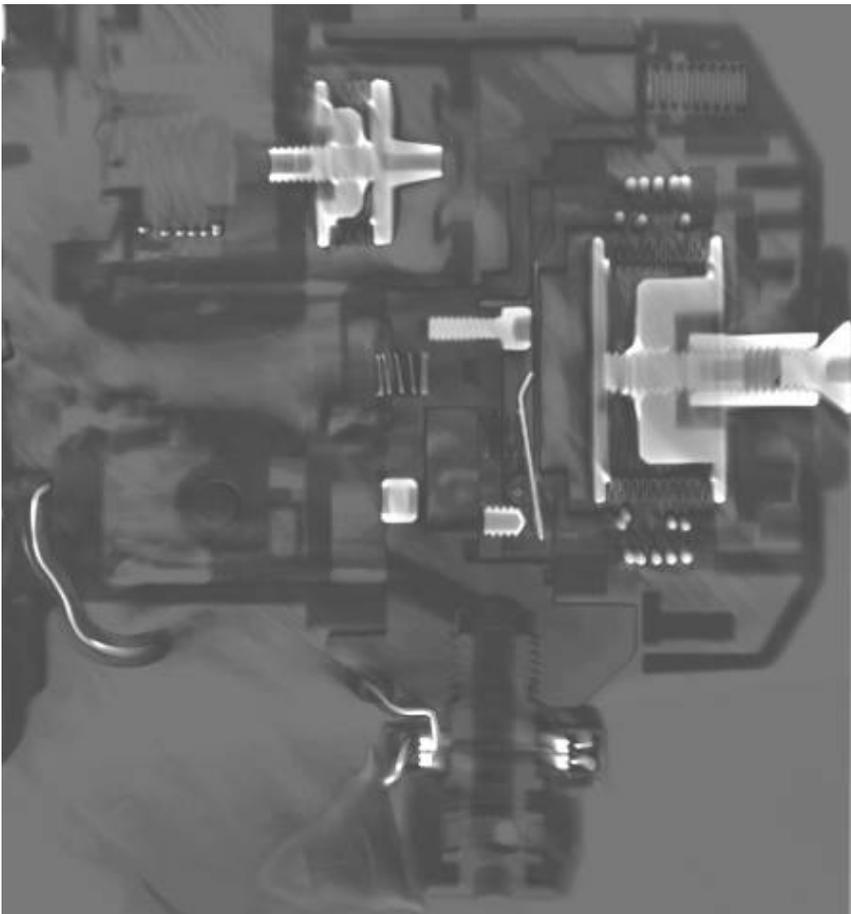
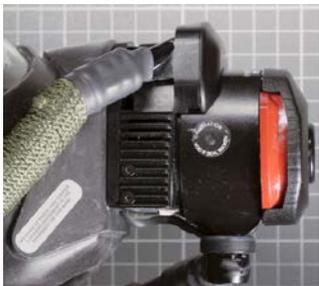
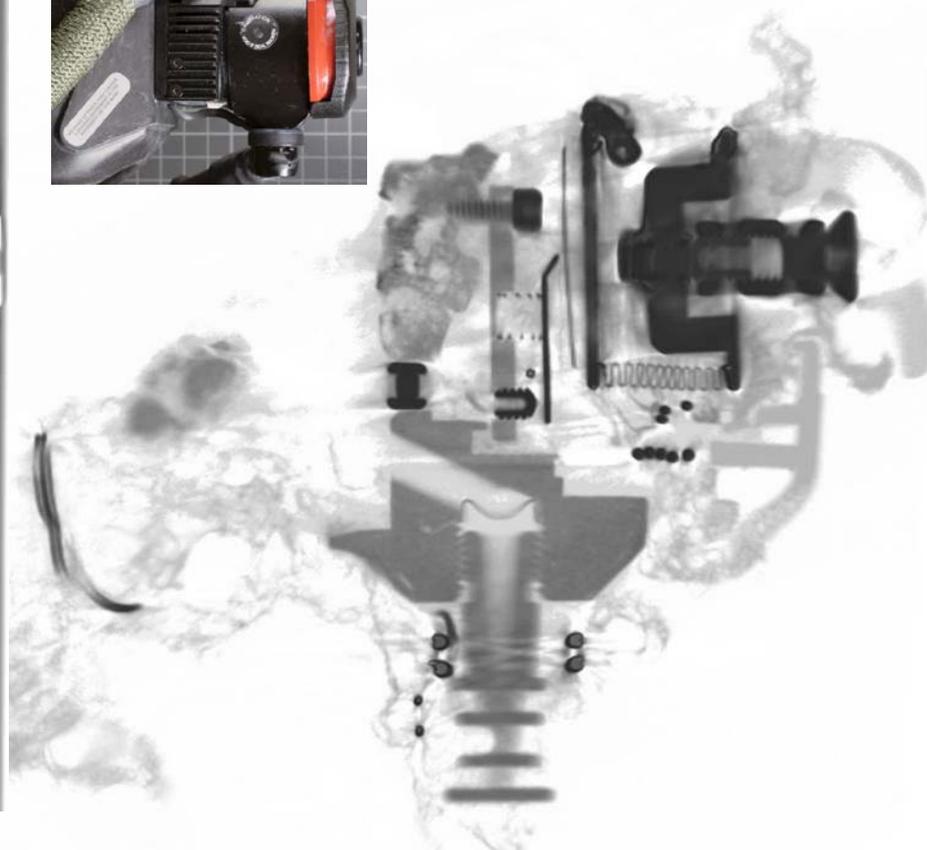
Comparative Analysis

Consensus was reached amongst participants that regulator was in “Emergency” position.

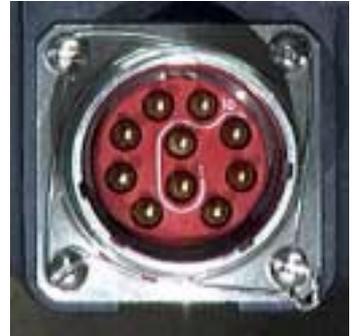
Multiple similar microswitch failures were observed by supplier.

The circuit between normally open contacts internal to switch were determined to be shorted together by external examination of connector pins.

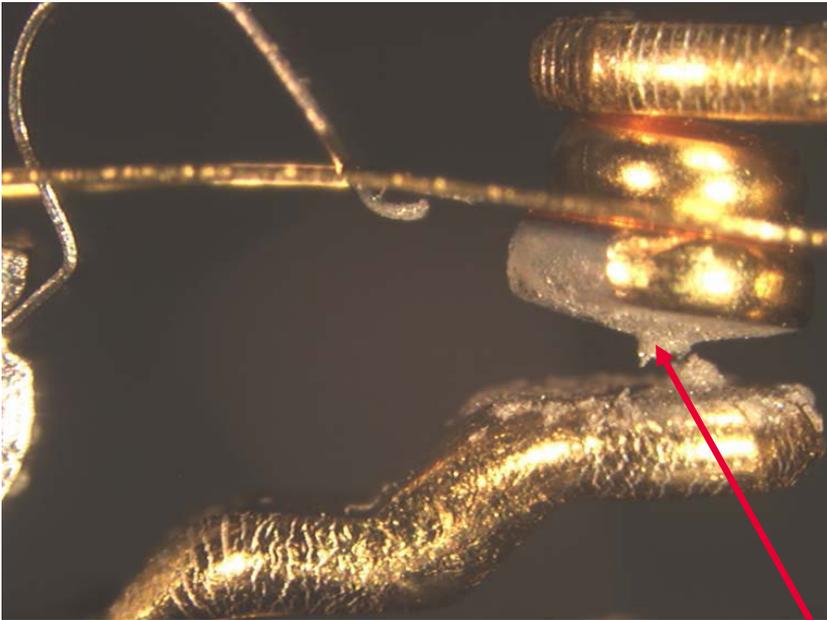
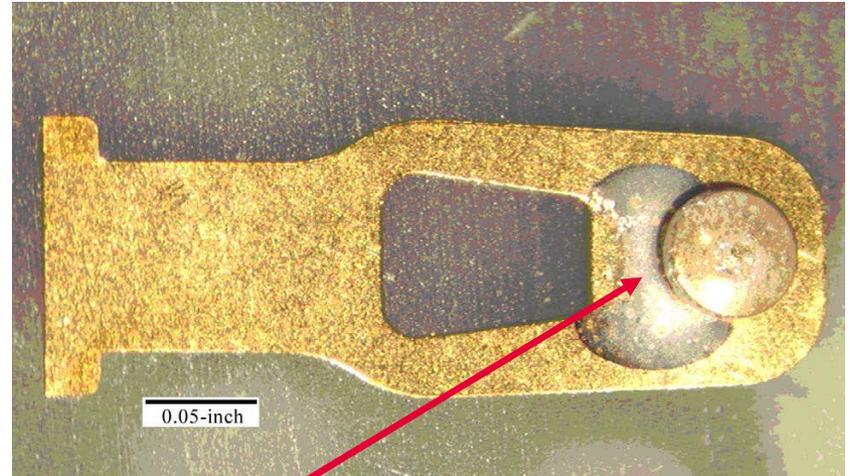
Physical Examination

Silver crystalline material bridged normally open contacts completing the circuit

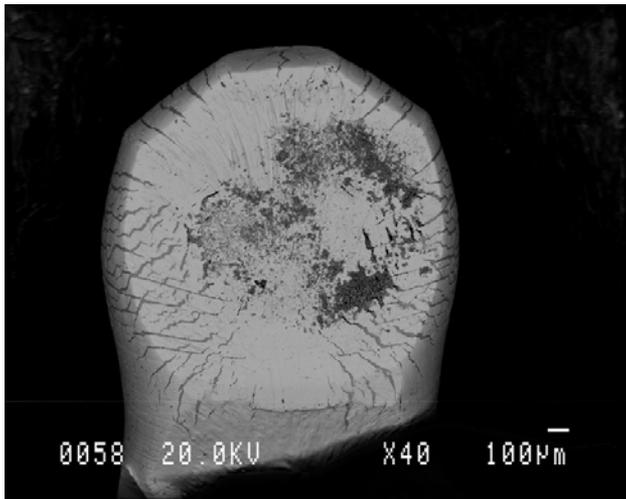
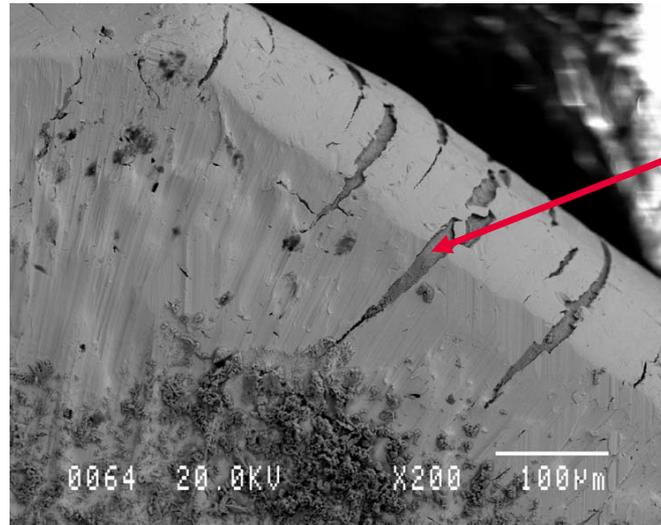
Microscopic Examination

Cracks in gold plating exposing silver substrate

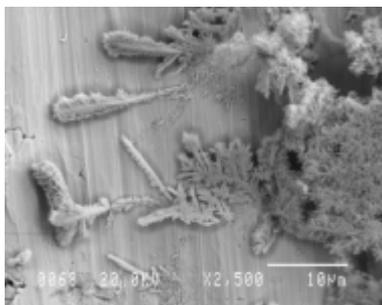
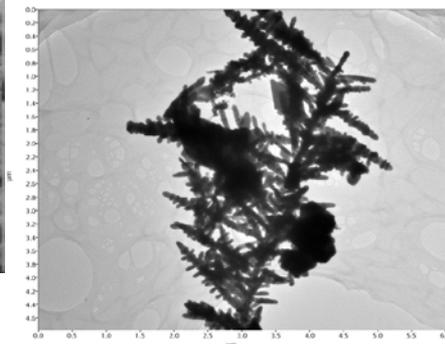
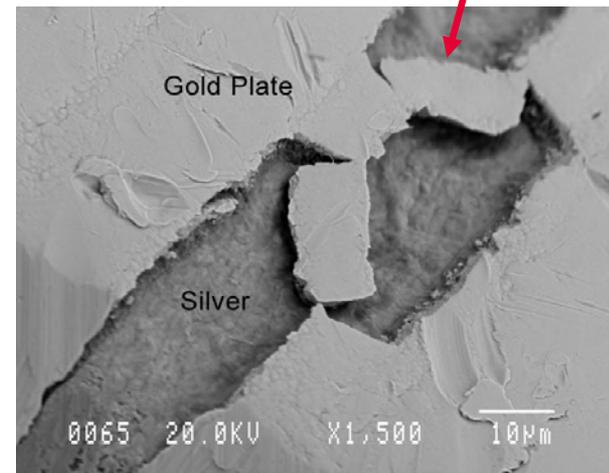
Silver dendritic formations

Highly skilled resources and analytical capabilities were shared and leveraged to perform detailed analysis to fully characterize unusual contaminant.
