UNSTABLE APPROACHES: A Global Problem

David Ross, MO5600
Senior Regional Operations Investigator
Transportation Safety Board of Canada

Mr. Ross worked as the operations team leader, and chair of the flight operations and weather groups, during the TSB investigation of a Boeing 737 controlled flight into terrain accident at Resolute Bay, Nunavut, on 20 August 2011. (1)

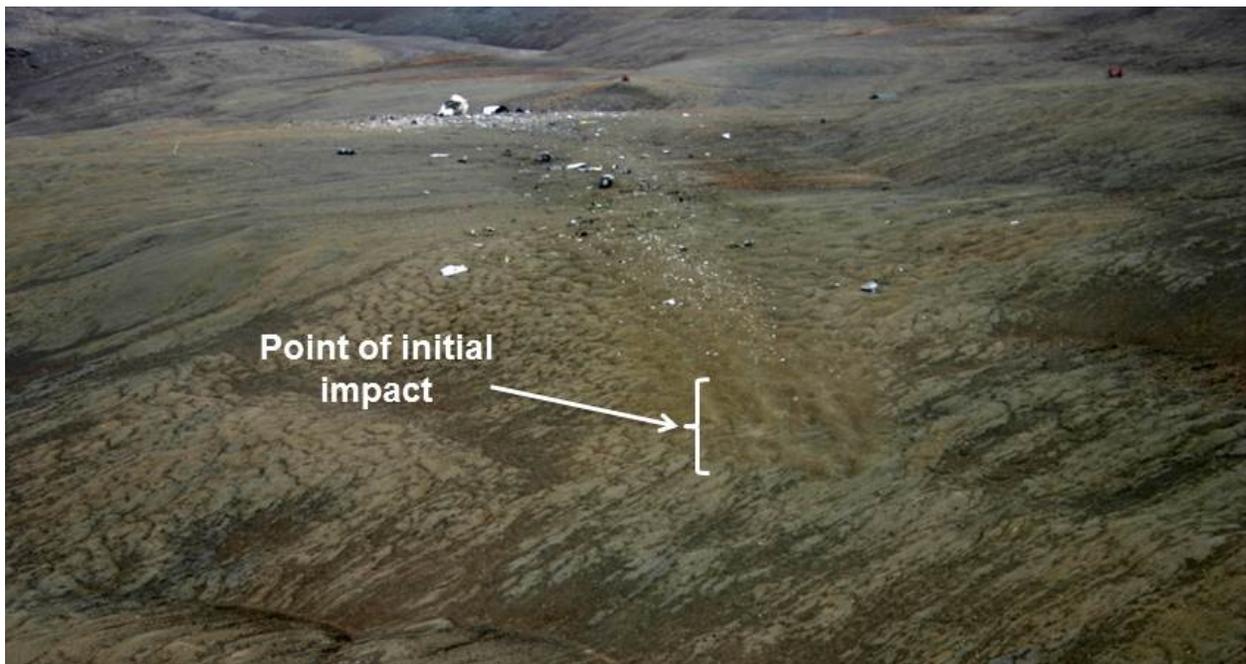
Figure 2: Accident Site Looking North

On 20 August 2011, a Boeing 737-210C was operating as First Air flight 6560 from Yellowknife, Northwest Territories, to Resolute Bay, Nunavut (Figure 1). During the instrument landing system approach to Runway 35 True at Resolute Bay, the aircraft progressively diverged to the right of course. The crew initiated a go-around after a ground proximity warning system “sink rate” alert occurred, but there was insufficient altitude and time to execute the manoeuvre and avoid collision with terrain. The aircraft struck a hill about 1 nautical mile east of the runway and was destroyed by impact forces and a post-crash fire (Figure 2). Eight passengers and all 4 crew members died in the crash, and the 3 surviving passengers were seriously injured. The accident occurred during daylight in instrument meteorological conditions.
