Links for a successful investigation C-212 Robison Crusoe Island Accident Case

by Luis Gracia
Airbus Defence & Space – Military Aircraft
Head of Product Safety
ISASI Member: CP0323

The study case presented is linked to the accident happened on September 2nd, 2011, with the C-212 Series 300, Model DF MSN 443, operated by the Chilean Air Force (FACH), where the aircraft was lost into the sea while performing a second approach to the Robison Crusoe Island airport (Juan Fernandez Archipelago - Chile) in high crosswind and bad weather conditions.

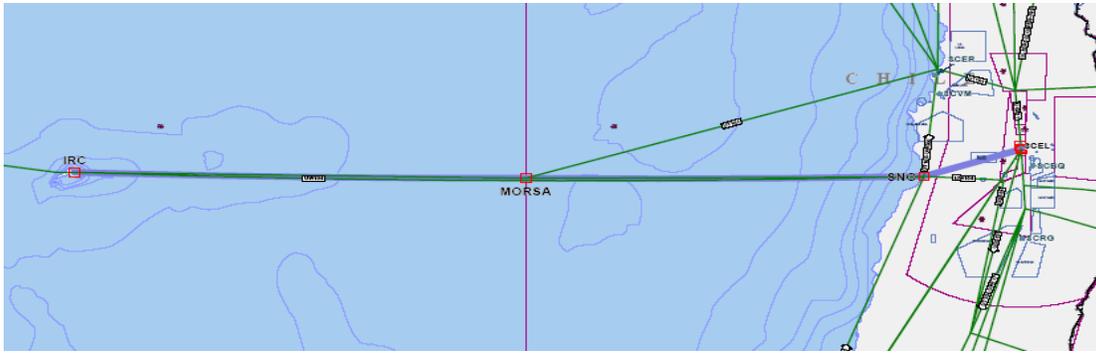
Figure 2

The route was partially covered by Santiago radar and aircraft was tracked up to 30 NM beyond MORSA reference point.

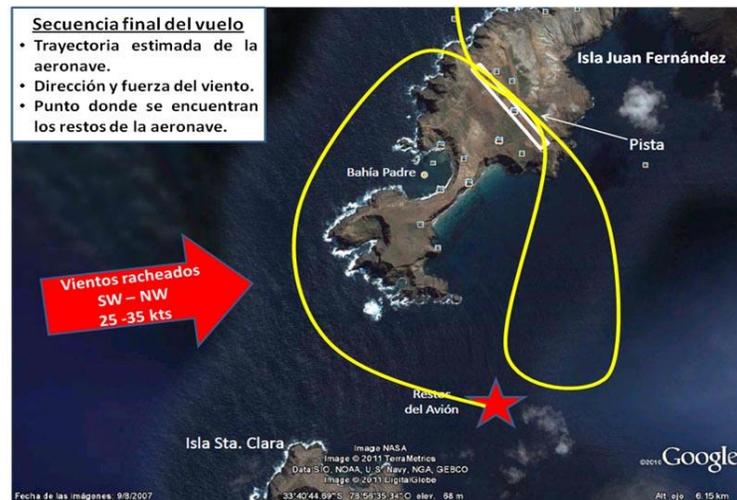
Figure 3

The aircraft flew-over the runway RWY 14 (North to South) and performed a teardrop maneuver to the right to invert heading for approaching to RWY 32, but this maneuver was performed at very low altitude, because the witness lost the aircraft view while performing it. Then, when the aircraft was on RWY 32 heading, a balked landing was experienced with high and gusty cross-wind, with the aircraft deviated at the right of the runway. When in the North, an open left turn for a new approach to RWY 32 was initiated through the channel between the airfield and Santa Clara Island but the aircraft disappeared below the hills around the airport and it was never seen again.

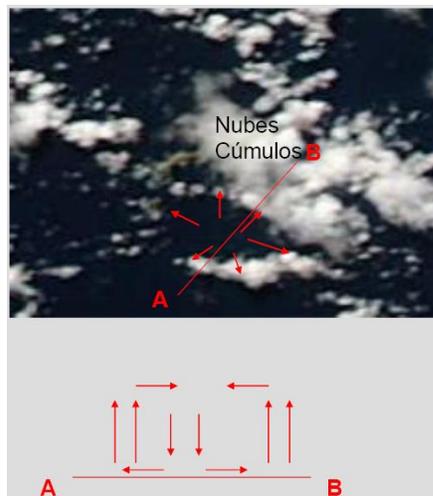
Figure 11

- The presence and characteristics of open cell allows concluding that there was a strong instability, and therefore at least moderate turbulence in the sector, and the presence of downwind between Santa Clara and Robinson Crusoe islands.

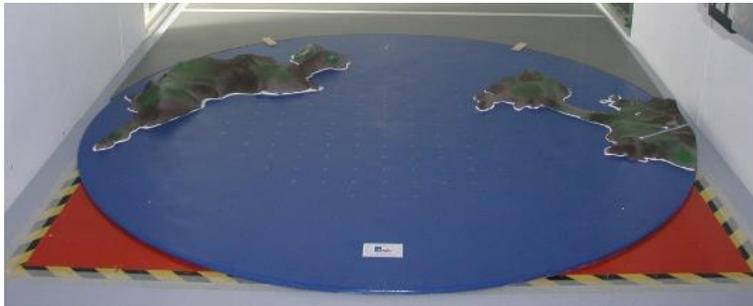
Figure 18

The Aeronautical Engineering School from Madrid Polytechnic University manufactured the escalated model and tested in their wind tunnel facilities. The flow pressure and speed were measured in all affected area. Smoke was also use for flow visualization.

Airbus Military also performed an analytical study using CFD (Computer Fluid Dynamics) models about wind flows around the islands, which was tuned to wind tunnel results and used as graphical support mean for them.

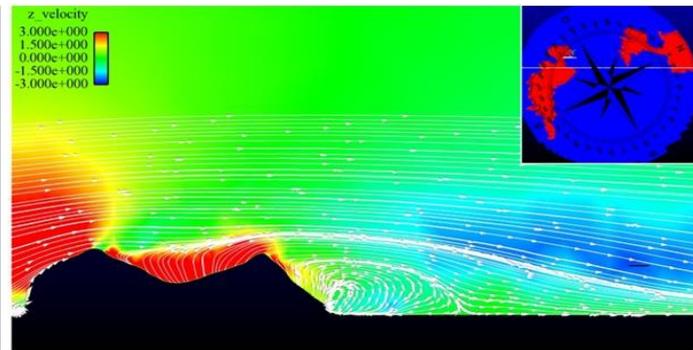
Figure 21

These vortexes caused rotational movements in the air mass, resulting in alternates upward and downward flows in a very short distance, resulting in changing strong gradients in airflow vertical speed and wind shear rates.
